# Aviation Investigation Final Report

| <b>Location:</b> | Pulaski, Tennessee | <b>Accident Number:</b> | ERA24FA058 |
| <b>Aircraft:</b> | Beech 35-C33 | <b>Aircraft Damage:</b> | Destroyed |

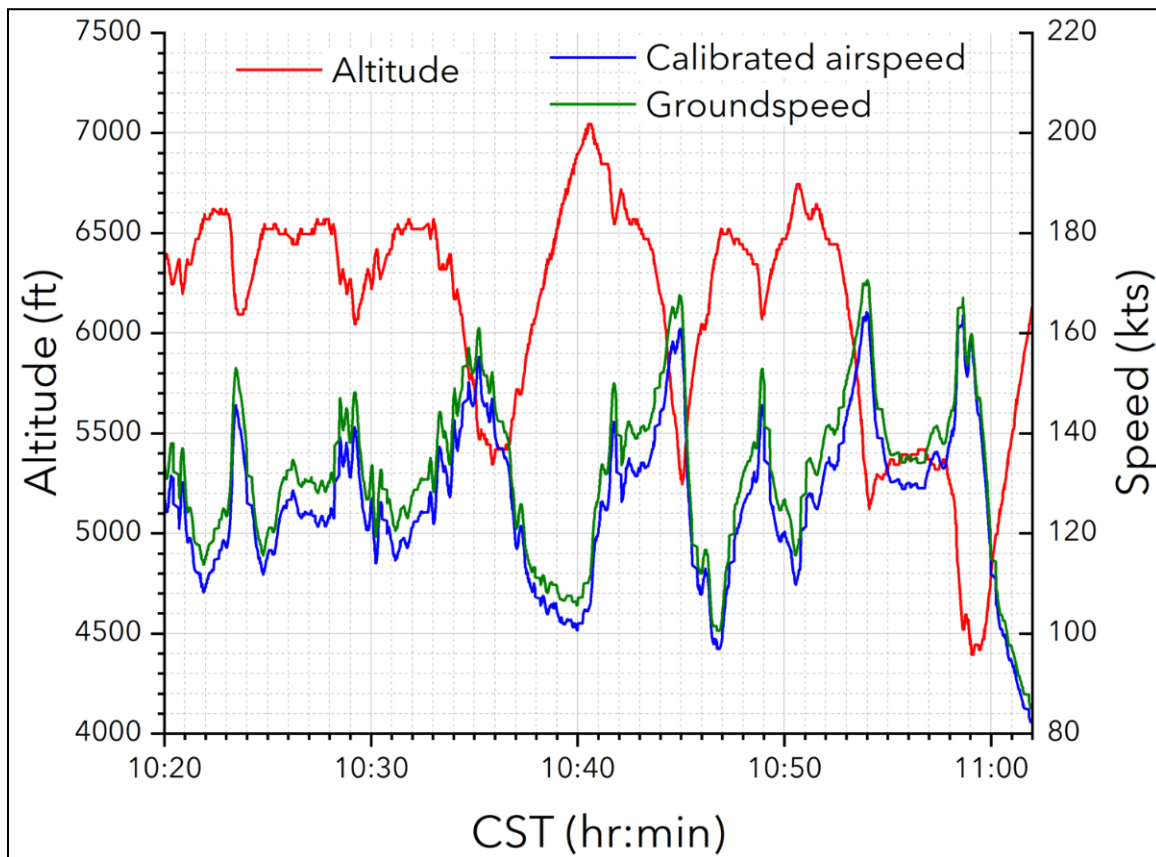
An aircraft performance study was conducted with ADS-B data, and the Beechcraft Debonair 35-C33 and Bonanza E33 F33 Pilot’s Operating Handbook and FAA Approved Airplane Flight Manual. The study indicated that, at 1033, the altitude and speed fluctuations became more pronounced and that the airplane no longer maintained a steady altitude for any significant amount of time. Weather conditions from the time of the accident indicated that the calibrated airspeed was about 5 kts lower than the groundspeed (figure 1). The airplane gained airspeed while descending and slowed while climbing. Airspeed fluctuated between 100 and 160 kts while repeatedly gaining and losing 1,000 to 1,500 ft of altitude.

The rate of climb varied between -1,200 ft/min during the descents to near 500 ft/min during the climbs. Smaller variations in altitude during the climbs and descents were also observed.

*Figure 1. Airplane altitude, calculated airspeed, and groundspeed for the final 40 minutes of flight.*

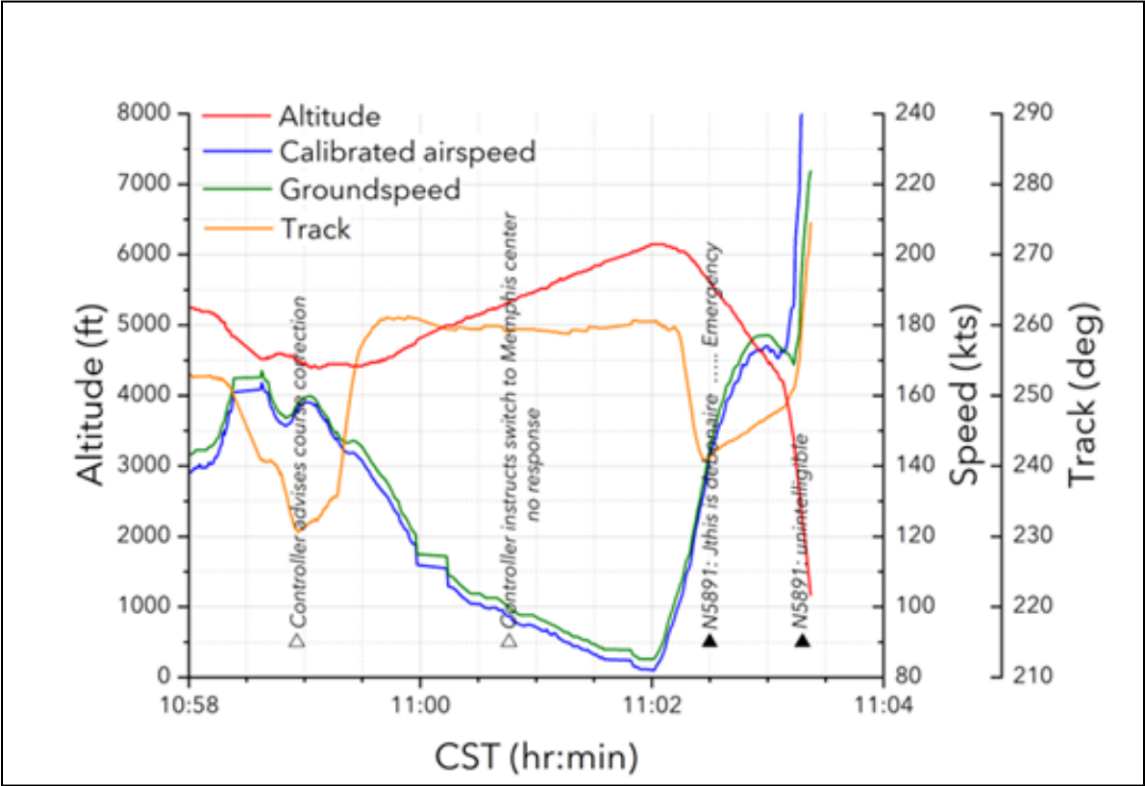
About 1103, there was a faint communication received from the pilot stating the “...this is Debonair, [unintelligible...] Emergency.” The transmission coincided with the airplane turning left, with a corresponding descent rate of about 2,000 ft/min and the airspeed increasing to over 170 kts (see figure 2). About 60 seconds later, a faint male voice transmitted, “[unintelligible], oh.... help us.” The controller’s subsequent attempts to contact the pilot were

unanswered, and there was no further communication from either the pilot or passenger. During this time, the airplane was in a rapid descent before radar contact was lost in the vicinity of the accident site. During the last several seconds of the flight, the airplane was on a ground track of 262° descending at an airspeed of 230 kts, and the descent rate was over 10,000 ft per minute.

Figure 2. Airplane altitude and track, with calculated airspeed and groundspeed and selected ATC communications, at the end of the flight.
